SNAITH & COWICK TOWN COUNCIL

Report to East Riding Yorkshire Council
in response to
Flooding of Snaith and East Cowick
February 2020

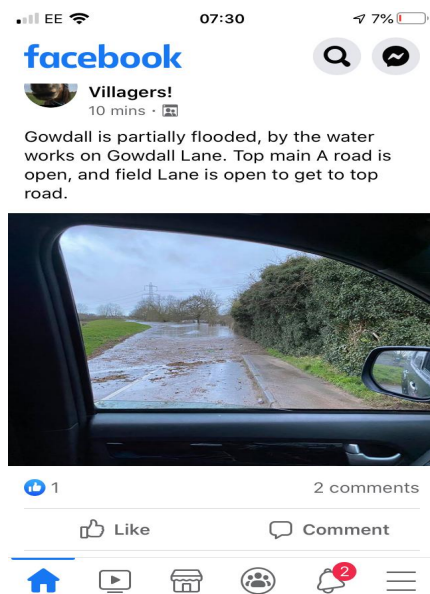
Ref: 25.02.2020 0731hrs

04:00 hrs	Residents of Westgate House on Gowdall Lane woken by local Flood Warden to warn of possible flooding
07:30 hrs	Town Clerk received image (taken from Facebook) of flood water on Gowdall Lane, rendering the road impassable. Photo ref: 25.02.2002 0731hrs

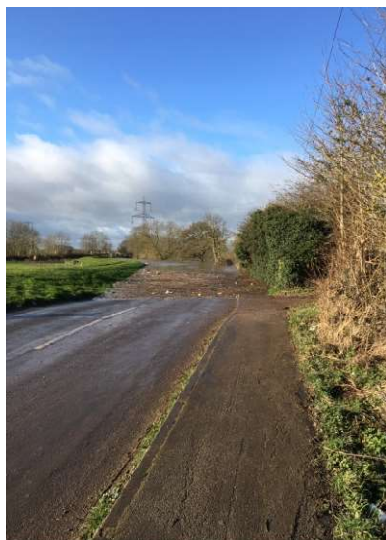
Ref: 25.02.2020 0935hrs

09:35 hrs	Gowdall Lane flooded but no road closure in place - traffic still approaching floodwater unaware of danger ahead. Pickhill Bank close to overtopping. Gowdall Lane flooded by Sewerage Works. Photo ref: 25.02.2020 0935hrs

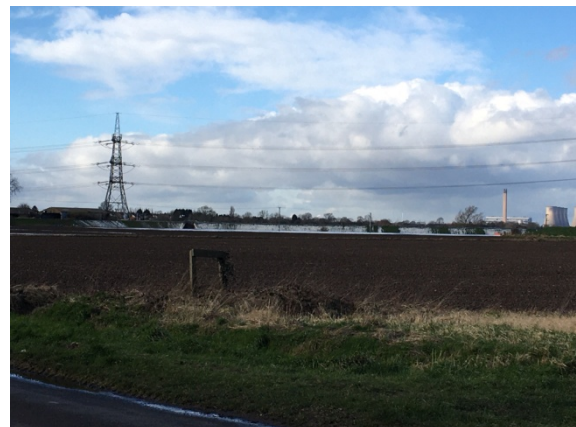
Ref: 25.02.2020 1154hrs

11:45 hrs	PICKHILL BANK STARTS TO OVERTOP
11:54 hrs	Water has started to fill initial fields of Snaith Ings. Photo ref: 25.02.2020 1154hrs
12:24 hrs	The field immediately east of Pickhill Bank is now full of water. Photo ref: 25.02.2020 1224hrs

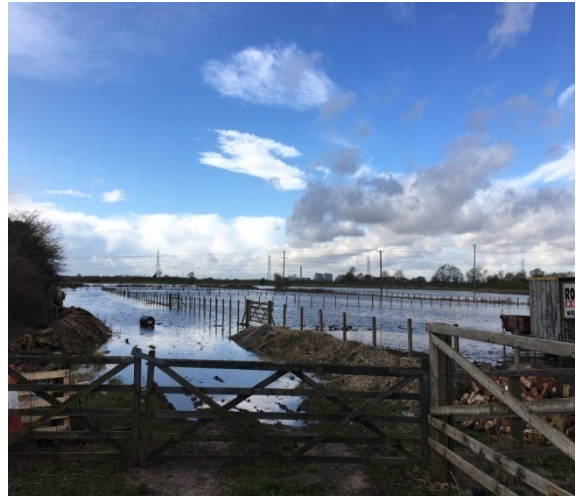
Ref: 25.02.2020 1302hrs

13:01 hrs	Water has reached the culvert going under the A1041 Selby Road. The lower parts of The Yorkshire Car Centre and Autotech are now seeing water ingress. Photo ref: 25.02.2020 1302hrs

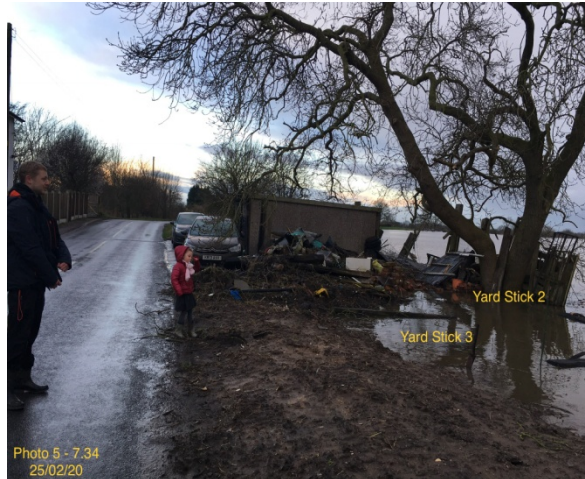
Westgate House 0734hrs

Water coming down Gowdall Lane towards Westgate House but still approx 50-75 metres away.

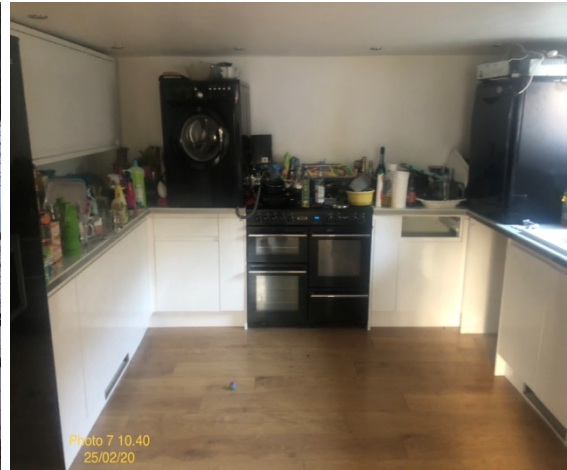
Westgate House Kitchen 1040hrs

EA also inspected garden area as water was just at kitchen windows level. They informed that house and Yorkshire Car Centre would not flood.

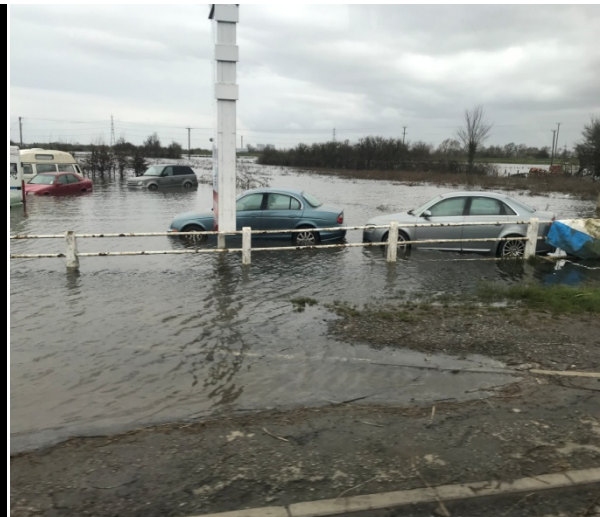
Yorkshire Car Centre 1236hrs

Water past the fence/gate and house.

Water begins to flood onto forecourt area of Yorkshire Car Centre.

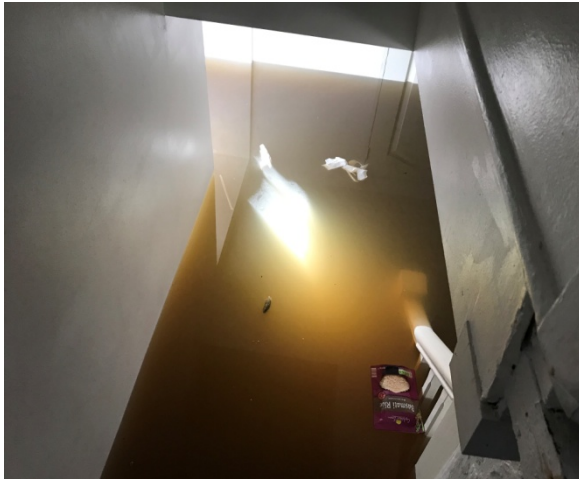
Westgate House Hallway 1328hrs

Water up to banister in kitchen.

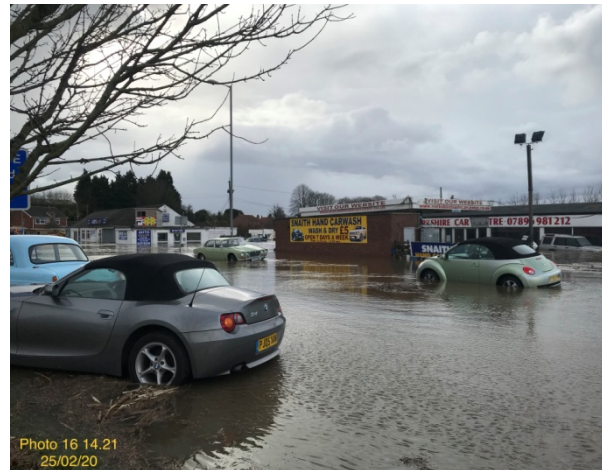
Yorkshire Car Centre 1421hrs

Yorkshire Car Centre is now 3ft under water and covering the road which is at a higher level.

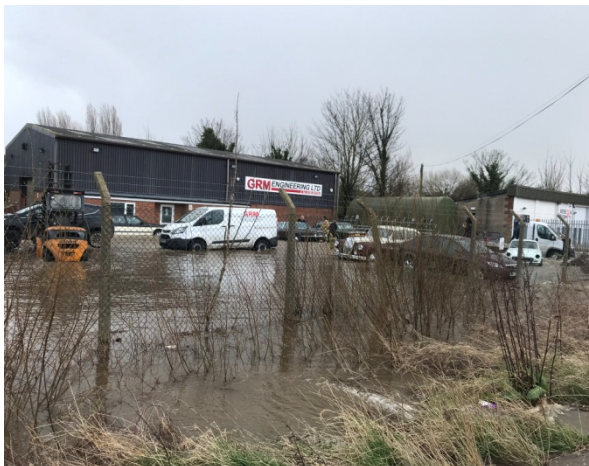
GRM 1421hrs

GRM Engineering (over the road from Yorkshire Car Centre and at a higher level) is now flooding. Photo shows that our cars that we placed there to save from flood water as unaware earlier of the severity to come. (Higher value vehicles had been removed from forecourt 1st were now damaged with flood water and many had to left and became fully submerged).

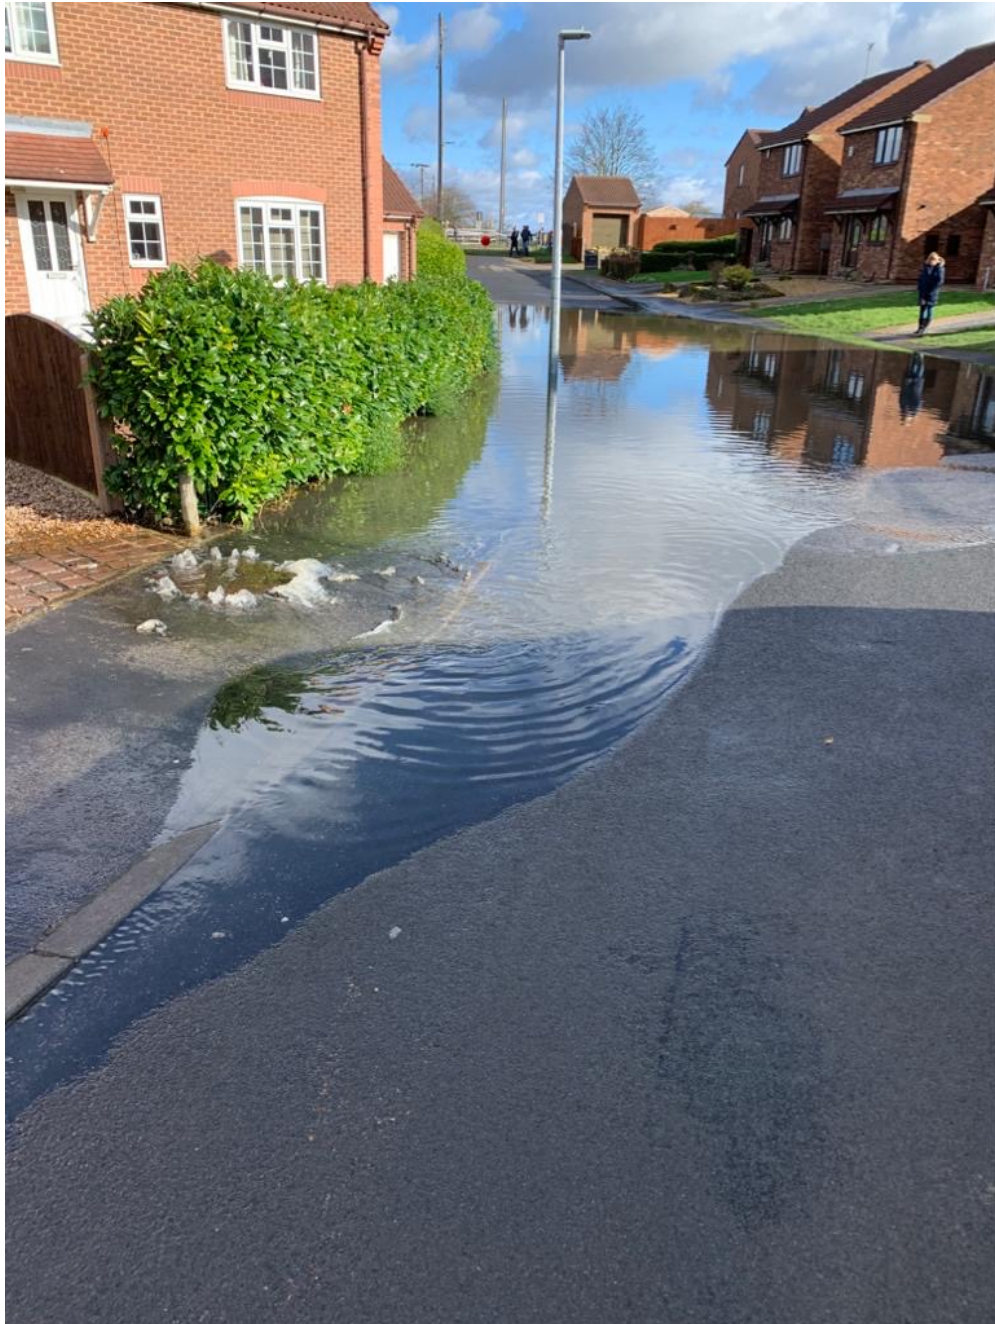
George Street - Snaith

Residents report water coming up from the drainage system. The photograph below was taken at approximately 1123hrs on Wednesday 26 February 2020;

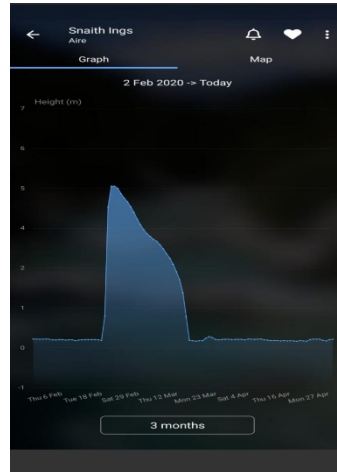
The image below depicts the water levels recorded at Snaith Ings in the lead-up to the flooding event, during the floods and that recorded in the weeks thereafter. The graph demonstrates a huge surge in water flow over a very short period of time.

The water which filled Snaith Ings and caused so many properties and businesses to flood was NOT a result of a breach of the riverbank, nor was it a result of a period of heavy rainfall causing localised flash flooding. The people of Snaith and Cowick are therefore keen to understand where this water actually came from?

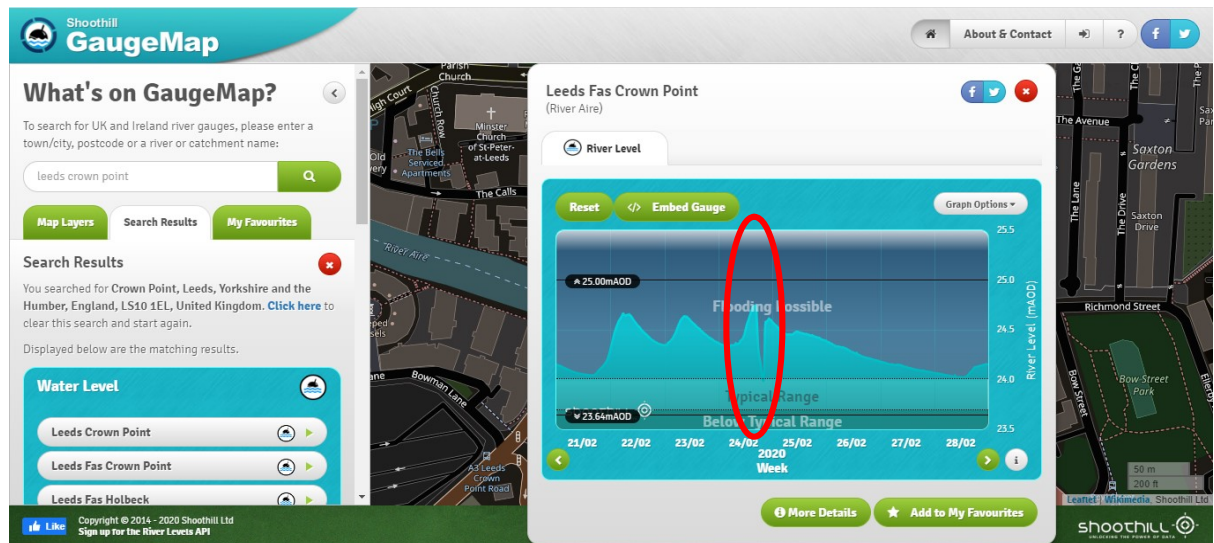
A further illustration below of the Leeds FAS Crown Point Weir also indicates a sudden drop in levels from a height of 24.678m down to 24.02m within the space of a few hours.

1. Has the weir been opened?
2. Where has the water gone so suddenly?
3. How does this impact on the River Aire and the Lower Aire Washlands downstream?
4. Was it the intention of the Environment Agency to 'sacrifice' the smaller towns and villages downstream to 'save' the City of Leeds?
